# Manhole Inspection Summary

Manhole # S57G\_\_020MH

**Location** Address: **3840 bank st**

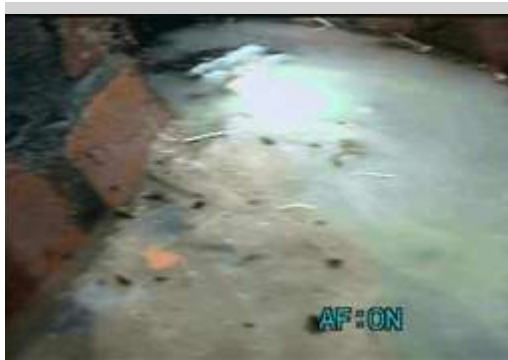
Defect 3

Condition: ☐ Sound ☐ Cracked ☐ Root Intrusion ☐ Deteriorated ☐ Leaks ☒ **Debris**

channel debris

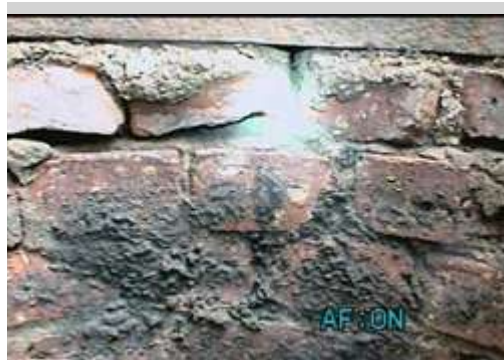
Defect 2

Condition: ☐ Sound ☒ **Cracked** ☐ Root Intrusion ☐ Loose Brick ☒ **Deteriorated**

chimney condition deteriorated

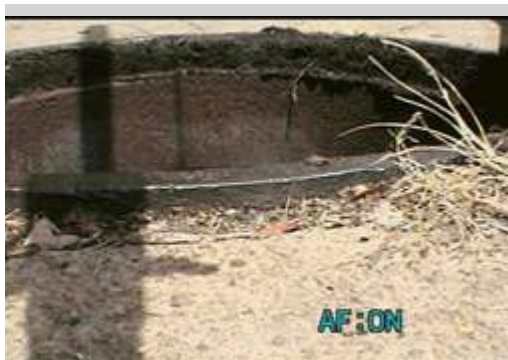
Defect 1

**Cover** Shape: **Circular** Diameter: **25.** (in.) Length: **0** (in.) Dist A/B Grade: **1** (in.)  
**5**

above grade

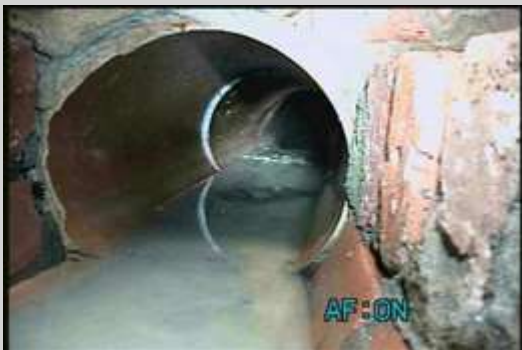
12 O'Clock Outflow

8 in. Circular Gravity Sewer  
Pipe Out @ 12 O'Clock

Invert Depth: 6.15 (ft.) Flow Characteristics: **Slow**

Deposits: ☒ None ☐ Mud ☐ Sludge ☐ Debris ☐ Grease

Infiltration: **None** Pipe Seal Cond: **Unknown**

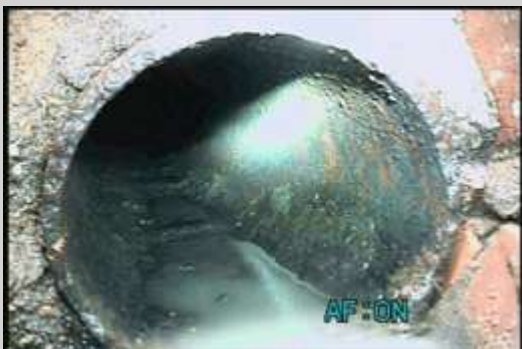
3 O'Clock Inflow

8 in. Circular Gravity Sewer  
Pipe In @ 3 O'Clock

Invert Depth: 6.14 (ft.) Flow Characteristics: **Slow**

Deposits: ☒ None ☐ Mud ☐ Sludge ☐ Debris ☐ Grease

Infiltration: **None** Pipe Seal Cond: **Unknown**
